CORPS OF ENGINEERS  
NATIONAL DAM INSPECTION PROGRAM  
BOSTON AREA - MASSACHUSETTS COASTAL BASIN

SLUICE POND DAM

MA 00236

DELETED FROM PROGRAM  
(LOW HAZARD POTENTIAL)

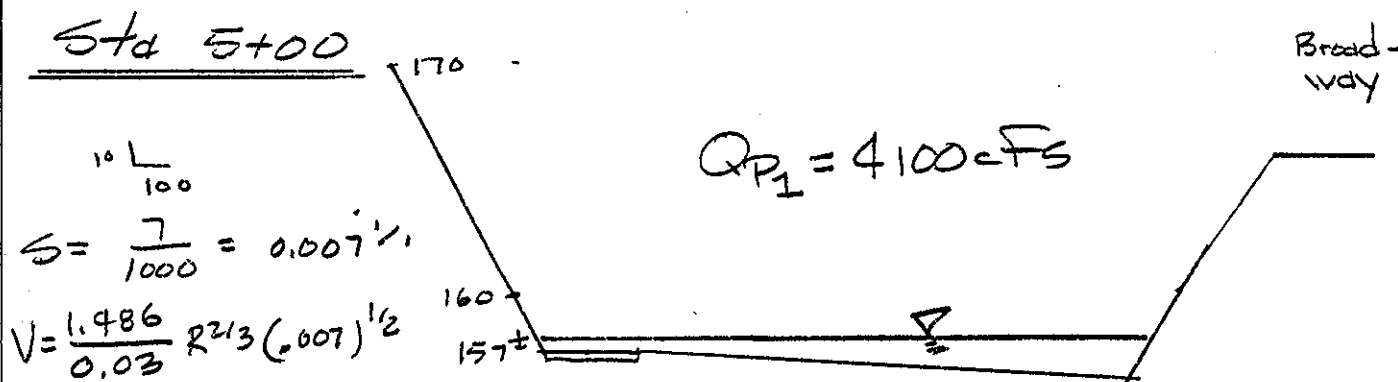
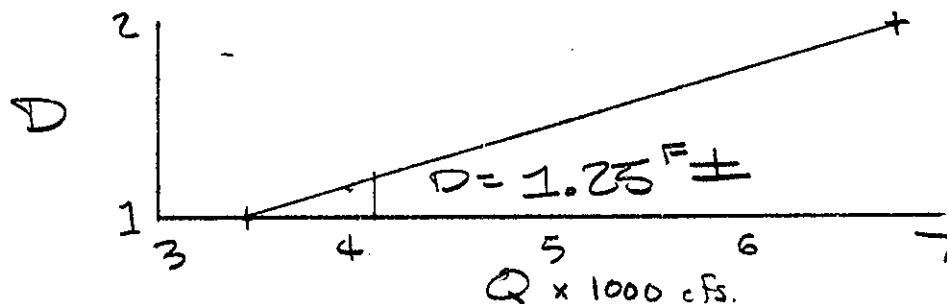
# Failure Outflow

D	WP	A	$R^{2/3}$	F'	V	Q
3	340	1210	2.34	4.14	9.69	11,726
2	340	870	1.88	"	7.77	6,760
1	310	560	1.486	"	6.15	3445

$$Q_{P1} = 4,100; \text{ cfs} \quad E1_1 = 1.25 \cdot \text{Stor}_1 = 8 \text{ c-f}$$

$$Q_{P2} = 4100 \left(1 - \frac{8}{322}\right) = 3997 \pm \text{ cfs}$$

$$Q_{P3} = 4100 \left(1 - \frac{7.5}{322}\right) = 4,005 \pm \text{ cfs}$$

$$E1 = 158.25 \pm$$

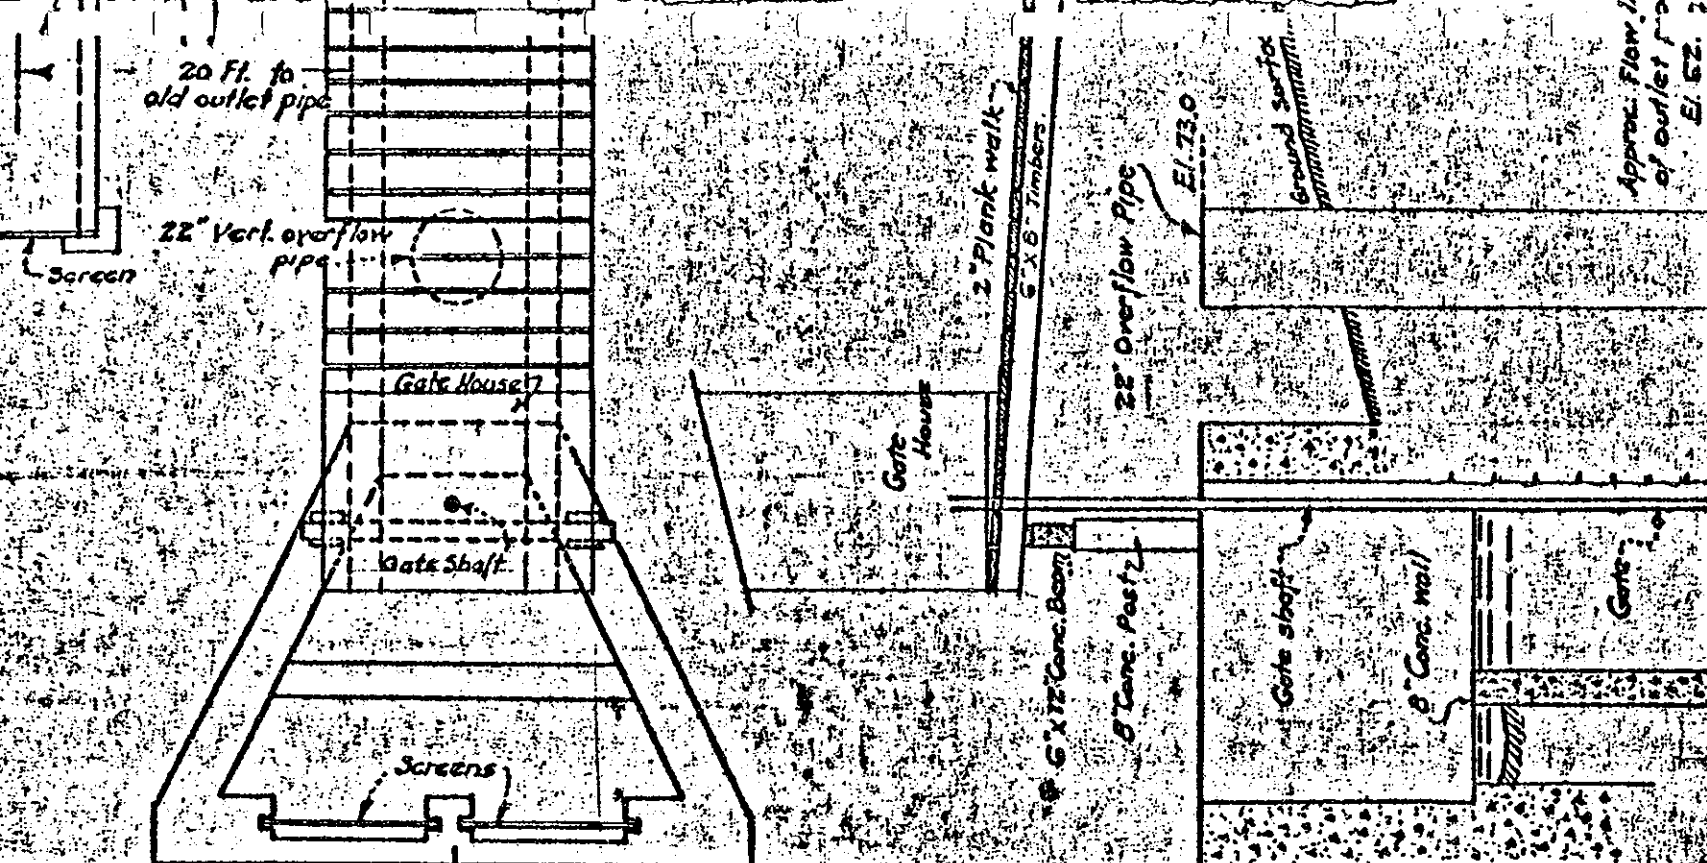
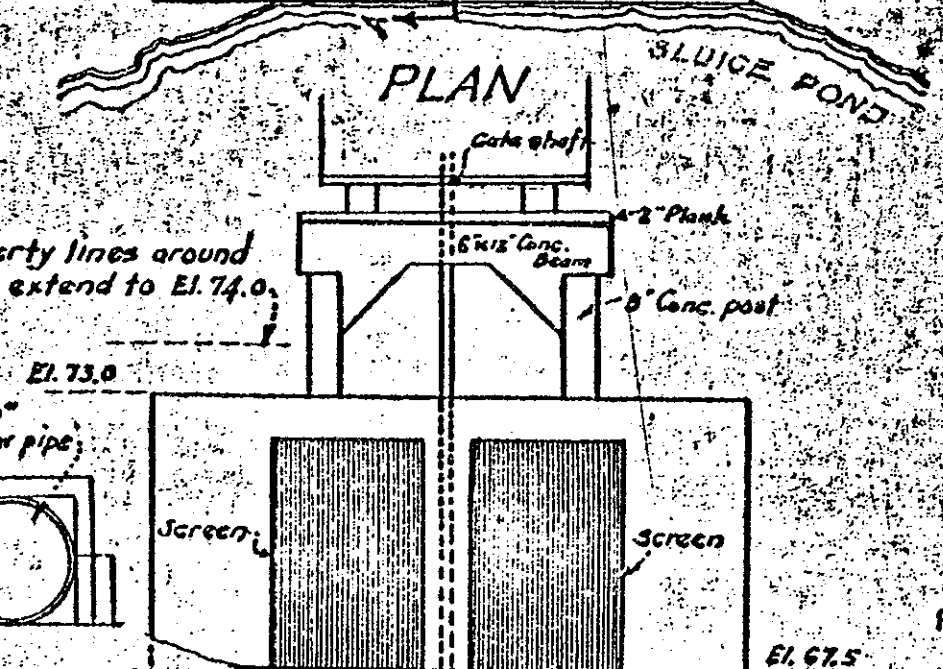
PLAN OF  
SLUICE POND DAM (D2)  
AT  
BROADWAY  
IN THE CITY OF  
LYNN

REPAIRS MADE BY MASSACHUSETTS  
FISH AND GAME DEPARTMENT  
1949. Scale 1" = 4'
